## REVITALIZATION IN ZEZULKA

# Revitalization of Litovicko-Sarecky creek

## LITOVICKO-SARECKY CREEK

## OPENING IN THE PARK HVEZDA

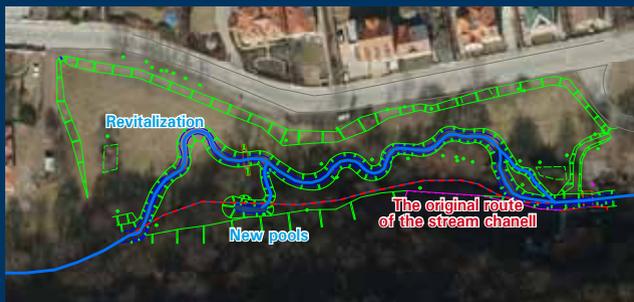
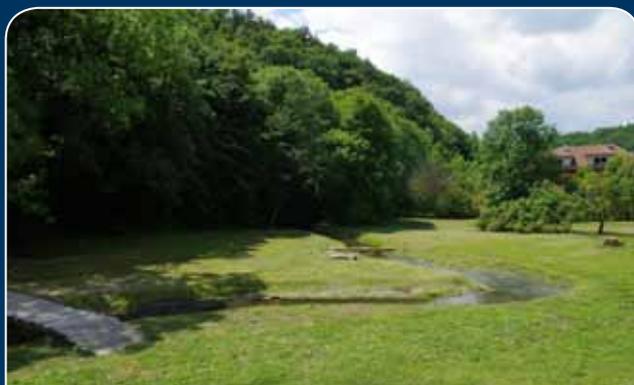
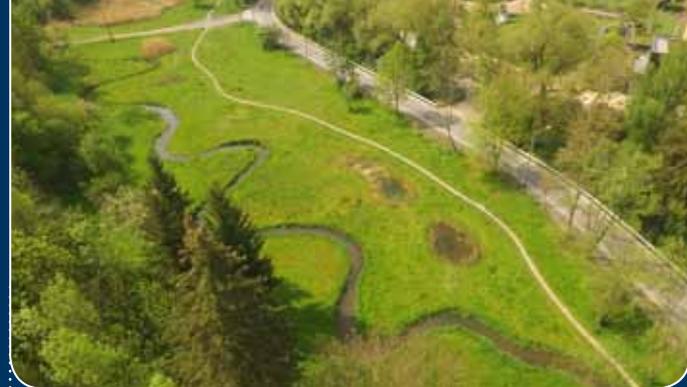
As a part of the revitalization the creek was transferred into the middle of the meadow and modelled into a nature close meandering stream with ponds and fords. The landfills were removed from the plains. Before returning to the original trough a fork of the creek was created to improve drainage conditions of the site. The shape and depth of the trough are based on the assumption that revitalized trough must not waterlog the surrounding meadow because it is used for recreational purposes by local residents. For better recreational use and maintenance there was a small wooden footbridge built in the upper part.

The original creek trough was backfilled with soil from the excavation of a new trough. Attention was paid to maintain as many as possible of valuable and original trees on the site during revitalization so that the creek trough would fit better into the new environment.

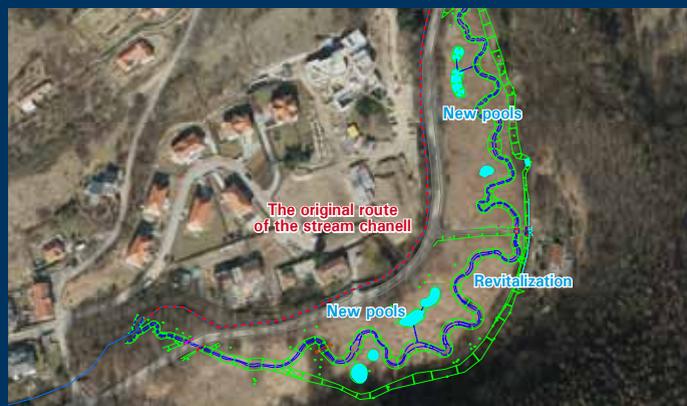
A meandering trough was again created here. It respected the most valuable areas of the floodplain. The revitalization was completed by 5 pools. The original creek trough was left there for better transfer of flood flows from the whole area. Water is transferred by distributive object assembled from big boulders into the revitalized and original trough. The remains of the original millrace were filled and thanks to cleaning up the edge of the adjacent forest water, meadow and forest environments were linked up. To increase attractiveness of the revitalization for people a gravel footpath and a wooden bridge over the creek were built across the centre of the meadow.

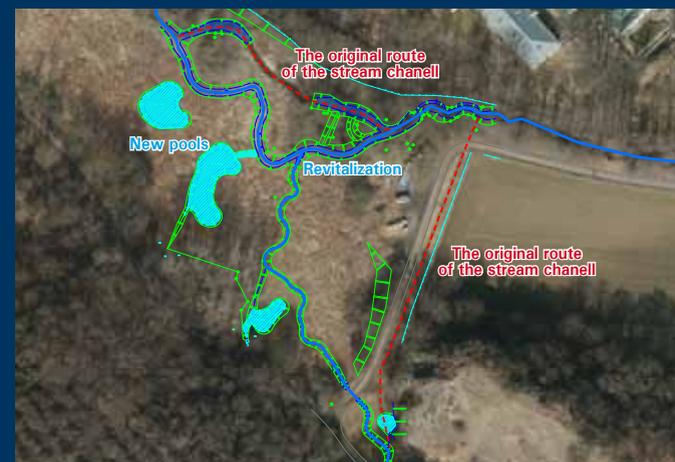
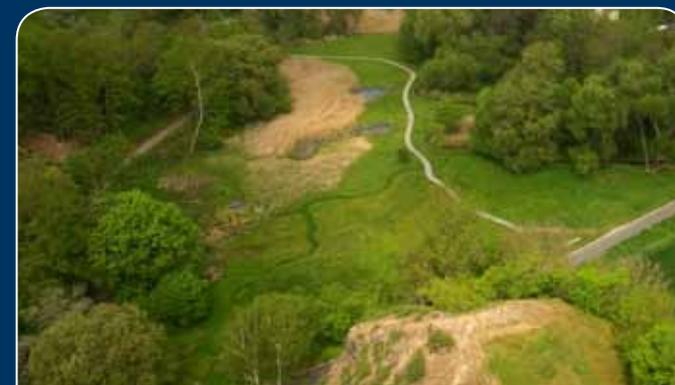
Treatment of the floodplain is based on the total waterlogging of the area. The floodplain is maintained by regularly mowed water meadows. For better access a wooden plant path was built in the centre of the floodplain. The completed revitalization was affected by floods in June 2013, which was an equivalent to flooding roughly five years ago. At all three locations the water spilled into the floodplain and thus a process of a new trough shaping started. Gravel fords and sediments as well as pools arose there.

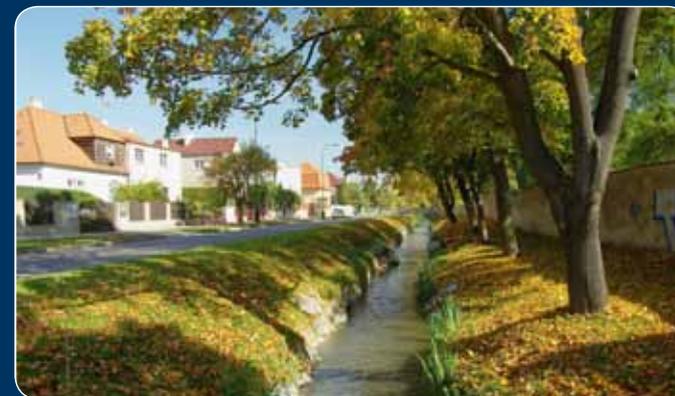
Before opening

The revitalization project dealt with uncovering the creek in the length of 280 m. The original concrete vaulting in the entire length was removed and a new opened trough was modelled into a nature close way. The newly opened trough is stabilized with rocks and partially with vegetation fortifications at the bottom and in the banks. Around the shores alder trees and shrub willows were planted. In the area below a bus stop a new footbridge was built to enter the Park Hvezda.
