REVITALIZATION OF ČIHADLA DRY RETENTION RESERVOIR

Revitalization of Rokytka Stream

Potoky pro život – Streams for Life

ROKYTKA

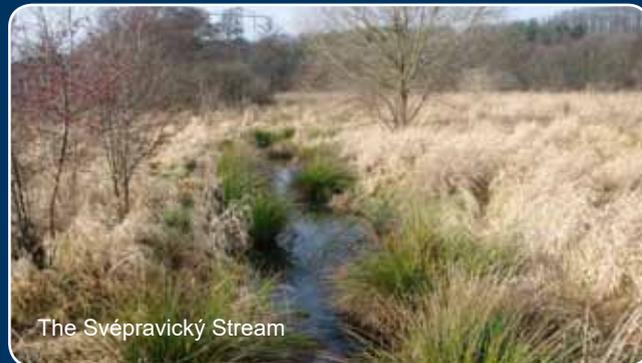
The Svěpravický Stream

The revitalization involved filling in the old fortified and

capacity channels and excavation of new, close to nature, shallow and meandering channels. Small ponds were built in places where the new channels crossed with the original channels. The banks of ponds were modified both gradually and steeply with respect to the evolvement of potential of fauna and flora. Other pools were formed from the original channel of Rokytka in places where mature trees grew.

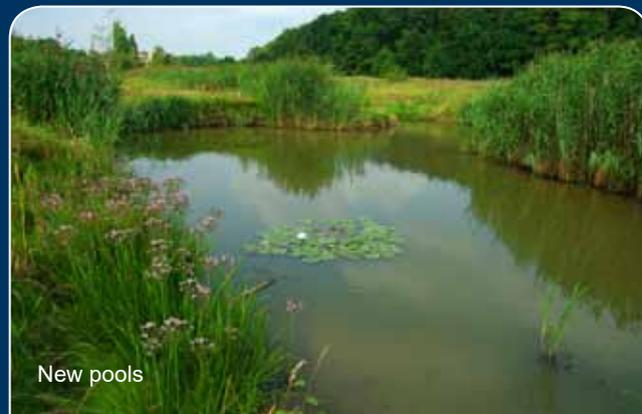
New pools

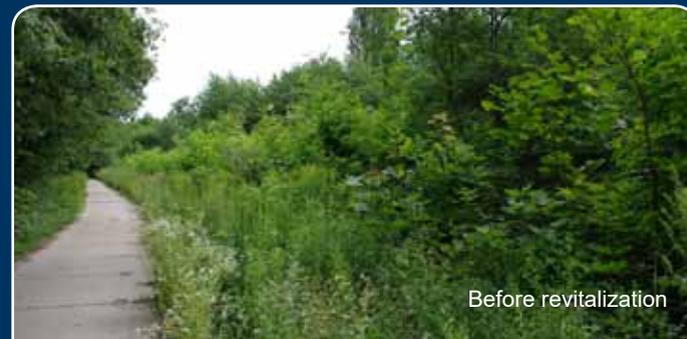
Even under the Smetanka hill Rokytka has changed significantly. Historically there was a meandering channel and even a millrace. In the 19th century Rokytka was straightened and its surrounding was covered. Afterwards the shores overgrew with impenetrable vegetation of *Robinia pseudoacacia* (Black Locust).

Before revitalization

Revitalization in this part of Rokytka involved excavation of landfills, expansion and diversification of the channel, and creating an ecological berm. Two small islands were formed in the channel and one wall for kingfishers, who often occurred in this area, but could not find suitable nesting conditions there. Several trunks from surrounding felled trees were placed and stabilized into the stream channel and would serve as dead wood in the water, which is a very important part of aquatic ecosystems. Thanks to the brightening the aquatic vegetation began to evolve in the stream, such as *Batrachium*.

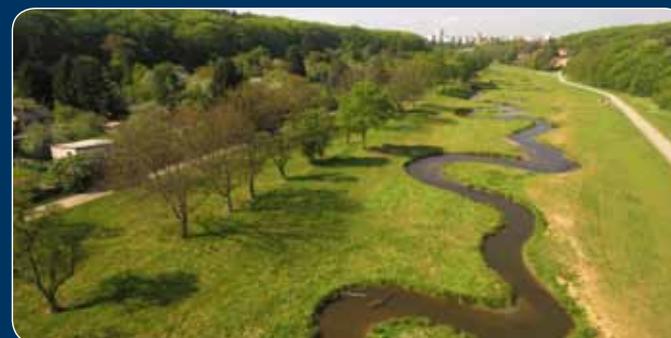
As a part of the revitalization the entire channel of Rokytká, over the Hořejší Pond, was transmitted into the meadow on the left bank. The aim was to create a nature close, meandering and shallow channel, as it probably had looked like before regulation. In order to maintain the capacity of the flow profile ca a 20 m wide depression (berm) was created in the centre of the meadow, in which a new channel was formed. A few small ponds arose in the curves and vertical walls for kingfishers were also established there. During the construction of the berm it was found out that the whole meadow was filled up with backfills of 1.5 m high.

The original channel of Rokytká was filled up. To increase the protection of the surrounding estates the meadow near the buildings was increased by about 0.7 m. A part of the event was also a construction of threshing bicycle paths. Generally, the whole area became more attractive and the surrounding landscape was linked with the aquatic environment.

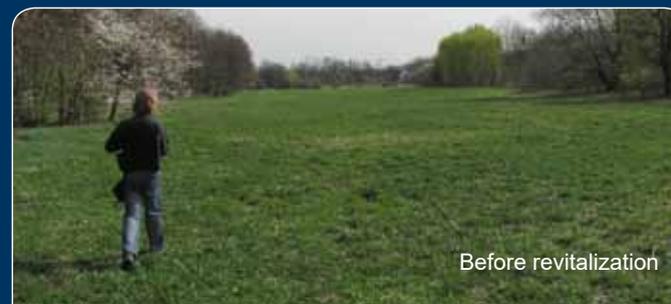
The Rokytká channel, over the Hořejší Pond, was straightened in the early 20th century and along its banks alley of walnut and pear trees was planted. Thanks to many years of neglected maintenance they overgrew, however, with self-seeded vegetation. The Rokytká's channel itself was downgraded to a channel used for quick water drainage. The bottom lacked segmentation, the left bank was inaccessible and completely devastated by large colonies of nutrias.

Before revitalization

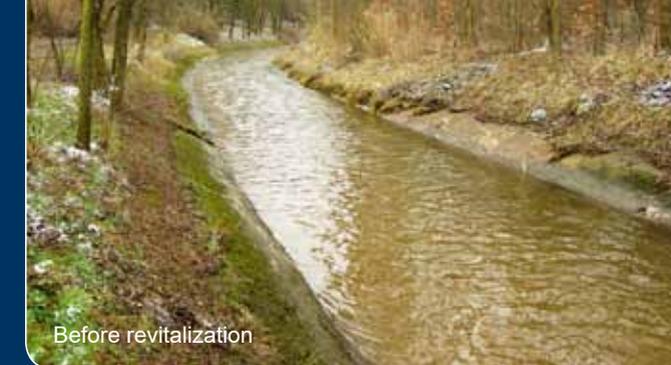
Before revitalization

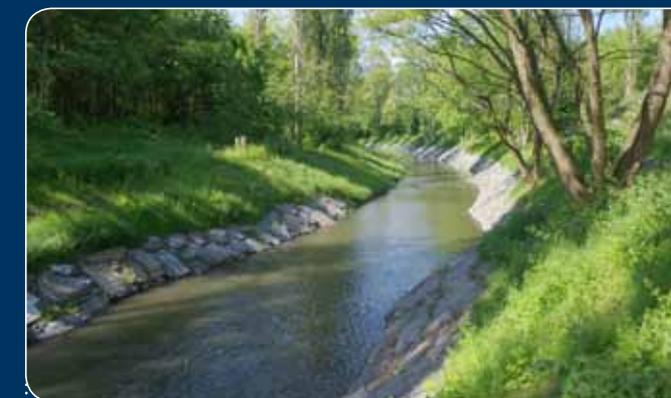
In the upper part of the modification, where the channel was not fortified and its banks were greatly undermined, the stabilization of the banks with large boulders was accomplished. The dying concrete fortification was knocked down and replaced by heavy boulder rockfill, so called alpine finish. If possible, the segmentation of the channel was made of stone layers. The bottom was left natural with seated stones forming a mosaic and a stone threshold. Thus a channel, which was close to nature and also stable, was built. It provides living space for water plants and animals. To make Rokytká more attractive, slow descents to the water area and a small seating area was built there.

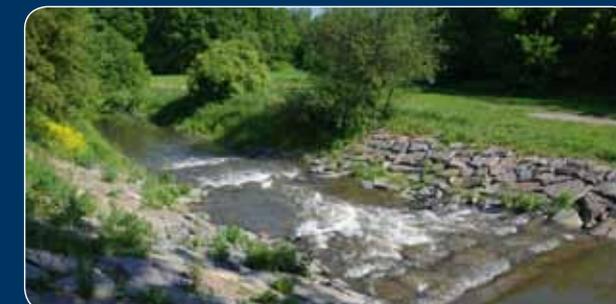
As a part of the revitalization of this part of Rokytká, the remains of non-functional Jermářův weir and supportive concrete constructions were removed. The height difference in the channel above and below the weir was solved by boulder chute. The boulder chute also replaced the original step at the inflow to the pond. Both of the chutes are migratory and penetrable for common species of fish found in Rokytká.

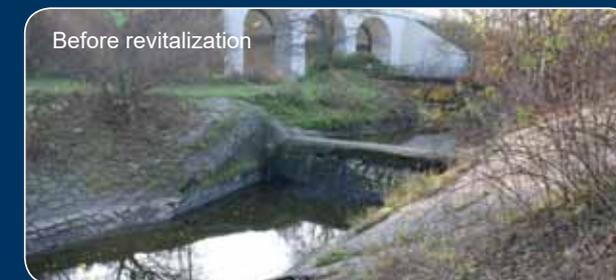
Rokytká, near the Hořejší Pond, has undergone many fundamental changes in the last century. It originally flew directly through the Hořejší Pond. In 1961, during the reconstruction of the pond and construction of a natural swimming pool, a dividing dam was built and the pond was rebuilt into a side pond. To fill the pond up a step was built in the drive and the channel was paved. Lower the downstream an experimental hydrostatic weir was built. It was called Jermářův weir.

Before revitalization
